To All Sylvaire Bushmaster and Husky Norseman Owners / Operators

From Gerry Golla / Corman Airpark December 2009

A possible serious problem with the wings of these aircraft.

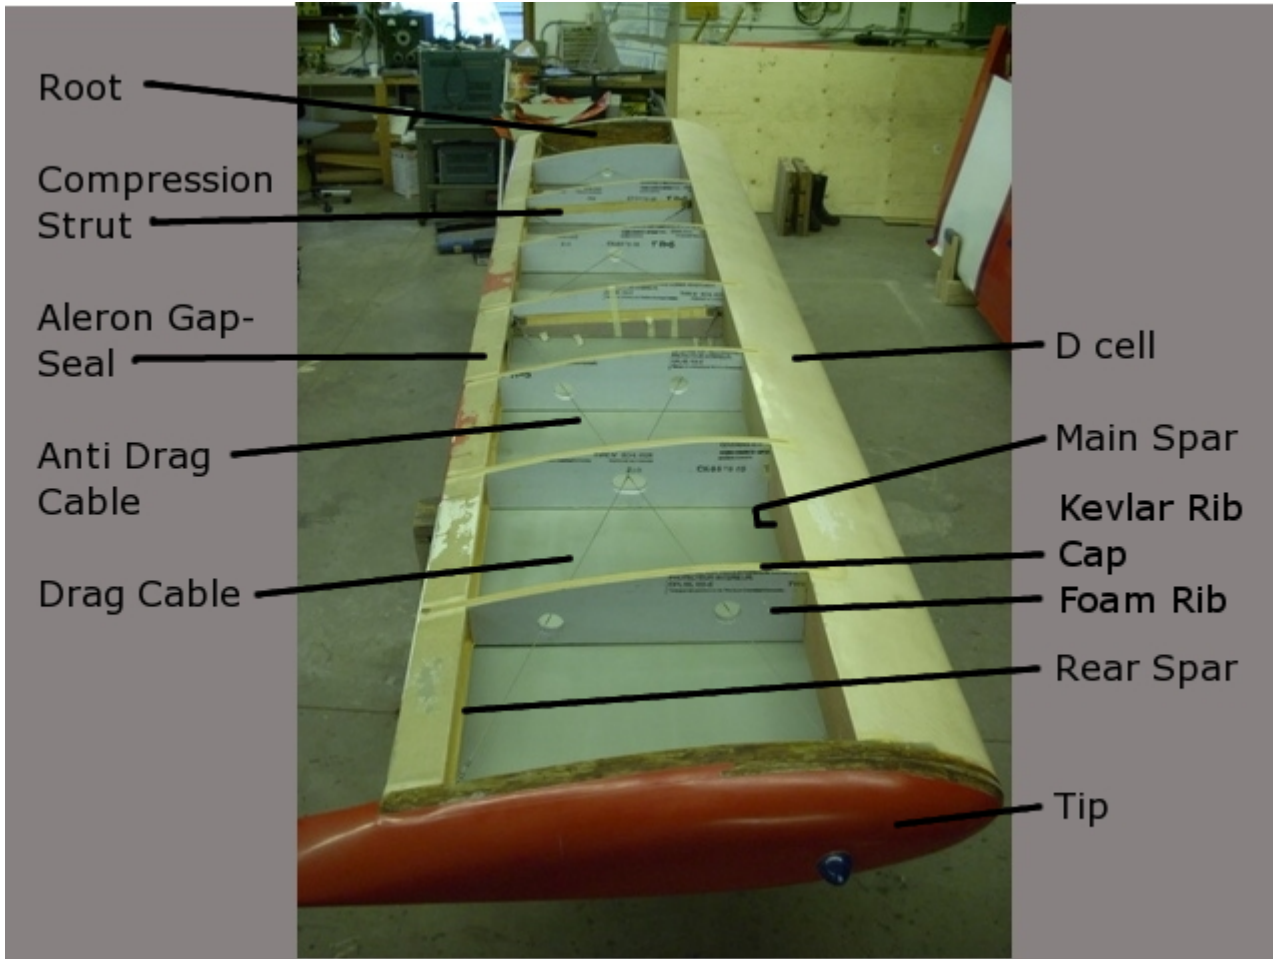
Labeled Wing Intact.jpg

In case you don't know what the gap seal I am referring to is, here is a diagram showing it.

The fabric on C-1AUE was NOT attached in any way to the rib caps. Once it started tearing there was nothing to stop it. They lost the entire top of the wing and the aircraft became unflyable.

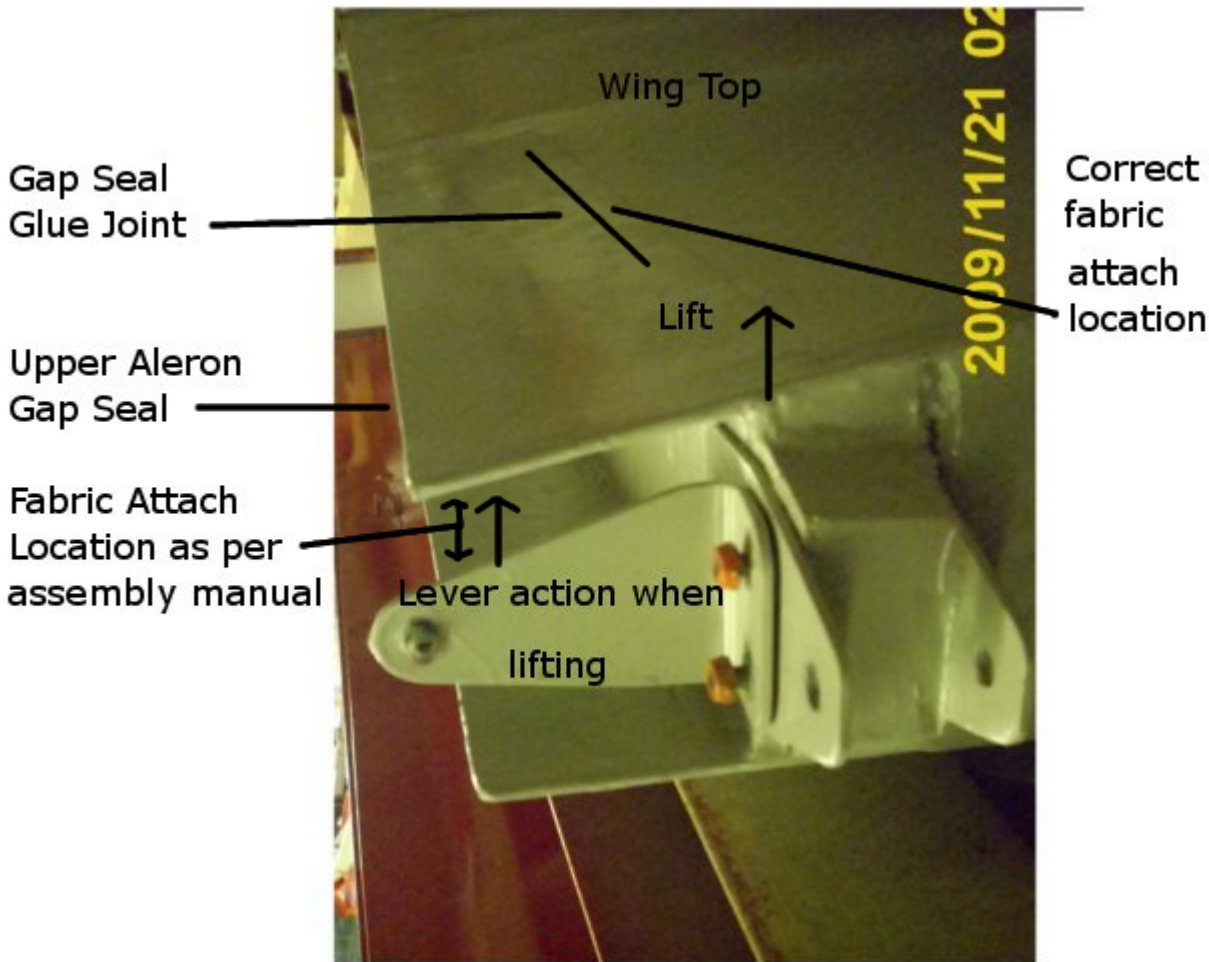
Labeled Gap Seal.jpg

If you picture the lift of the wing pulling upward on the top fabric of the wing and the fabric is not attached to the gap seal over the glue joint that holds it to the wing, then every time the wing lifts, the rear floating end of the gap seal is pulled upward by the fabric. The gap seal becomes a lever and it puts tremendous loads on the glue joint. This is not just a small pull either. Under normal flying conditions it amounts to close to 400 lbs distributed along the length of the gap seal. That is in smooth air and that is for EACH WING! Glue joints are only effective in shear loadings and this is definitely NOT shear!

Over time this stress on the glue joint will cause it to fail and the gap seal may start to show signs of separation. This separation can be difficult to spot, especially if you have no reason to be looking for it. The first indications of it are often warpage of the gap seal along its rear edge. This is the first thing to look for.

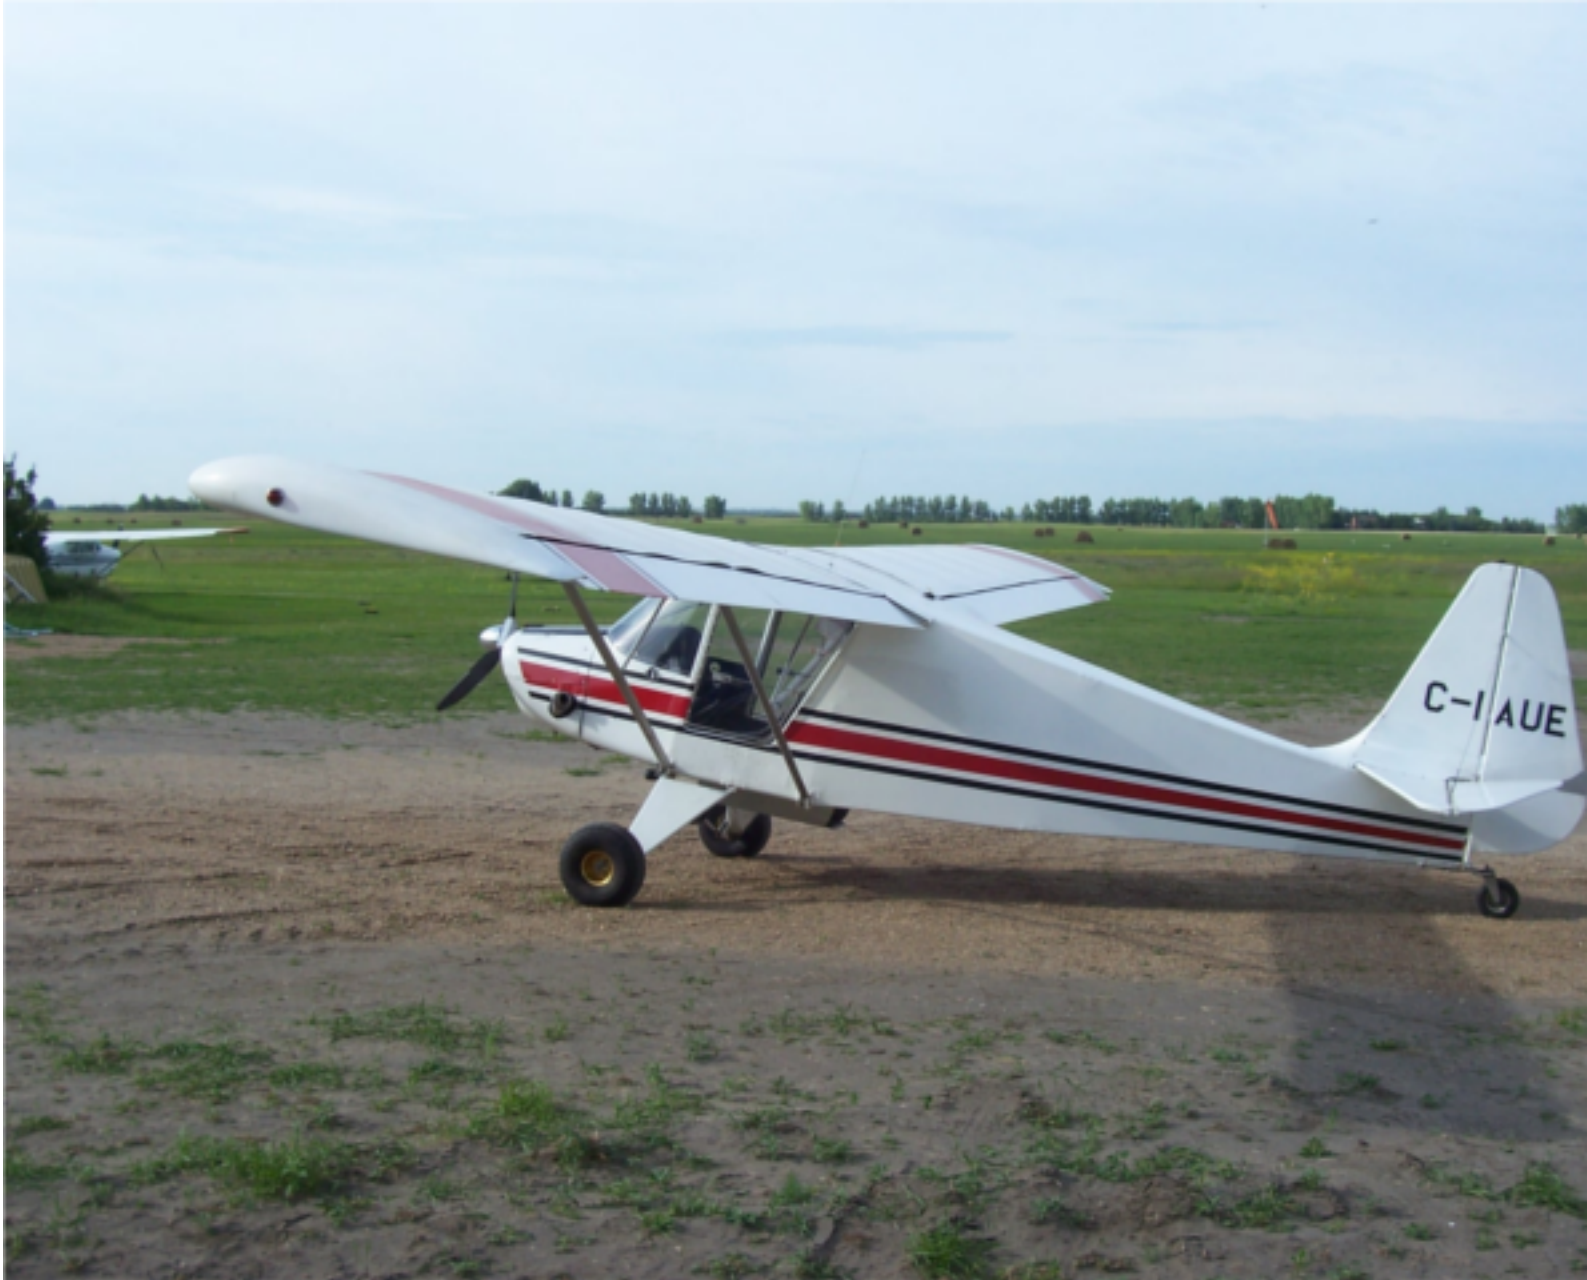
C-1AUE Stock.jpg

These gap seals dont look too bad, but you can see the waves in the ones on the left wing. This picture was taken about 2 weeks before the fatal crash. The starting point of the seperation is believed to be where the inner and outer seals join, just above the rear strut.

Next, take a coin, a quarter works well. Tap gently along the entire lenght of the gap seal, directly over its glue joint with the edge of the coin. It should sound solid over it's entire length. Hollow sounding spots are not good. You should check both the upper and lower seals this way.

If you can worm your fingers under the seal between it and the aleron, pull upward, quite hard, 10 - 20 lbs. If the seal shows any

signs of trying to come free..... well again not good.
